STRUCTURAL EXISTING CONDITIONS REPORT

WESTPORT HIGH SCHOOL
WESTPORT, MASSACHUSETTS

May 16, 2016

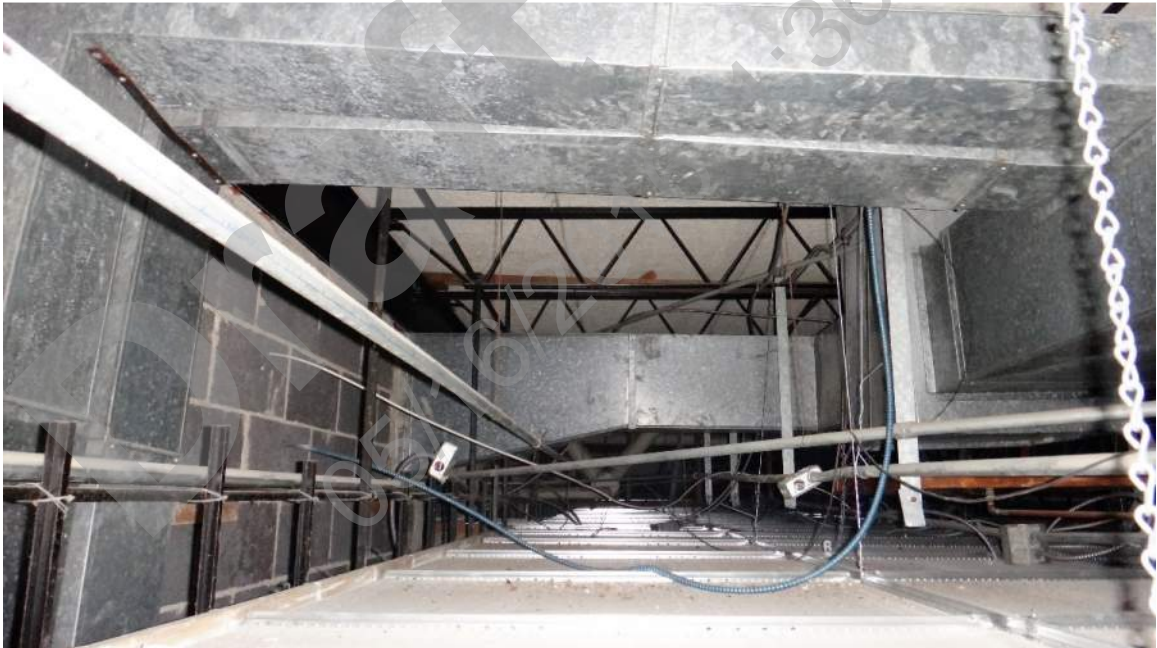
PHOTO #11

- The existing steel roof joists at the 1958 extension to the classroom wing may have inadequate capacity to resist the code minimum roof snow loads.
 - **COMMENT:** Assuming the minimum size for the existing joists at the measured depth, the joists are inadequate to resist the code minimum roof snow load. Detailed measurements of the existing joists should be performed to determine their actual size and capacity.

This photo shows the existing roof joists and metal deck at the 1958 extension to the two-story portion of the Original School Building region.

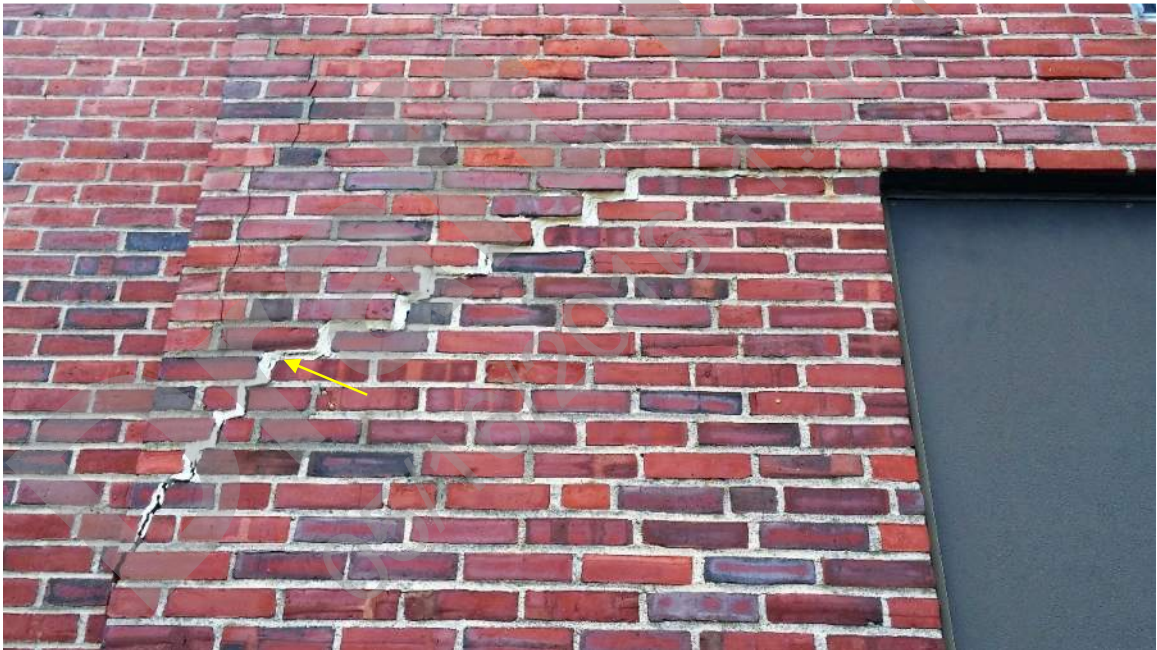
PHOTO #19

- **Minor cracking of the brick veneer at varied locations around the building perimeter (Photos #19 and #20):**
 - **COMMENT:** Cracking of brick veneer can by caused by a number of reasons, including thermal or moisture expansion of the brick, localized overstress (e.g. lintel bearing), differential stiffness of supports, and settlement. It is unknown whether the cracks propagate through the entire thickness of the wall, however, they appear to be minor in nature. The root cause of the cracking should be thoroughly investigated and repair details (e.g. crack sealing and repointing ant nonmoving, nonstructural cracks or crack stitching at moving or structural cracks) should be developed accordingly.
- **Minor deterioration of masonry and spalling of the brick veneer at varied**

This photo shows a previously repaired crack (and displaced brick) in the exterior brick veneer. Note the additional cracking to the left and displacement along a portion of the previous repair.

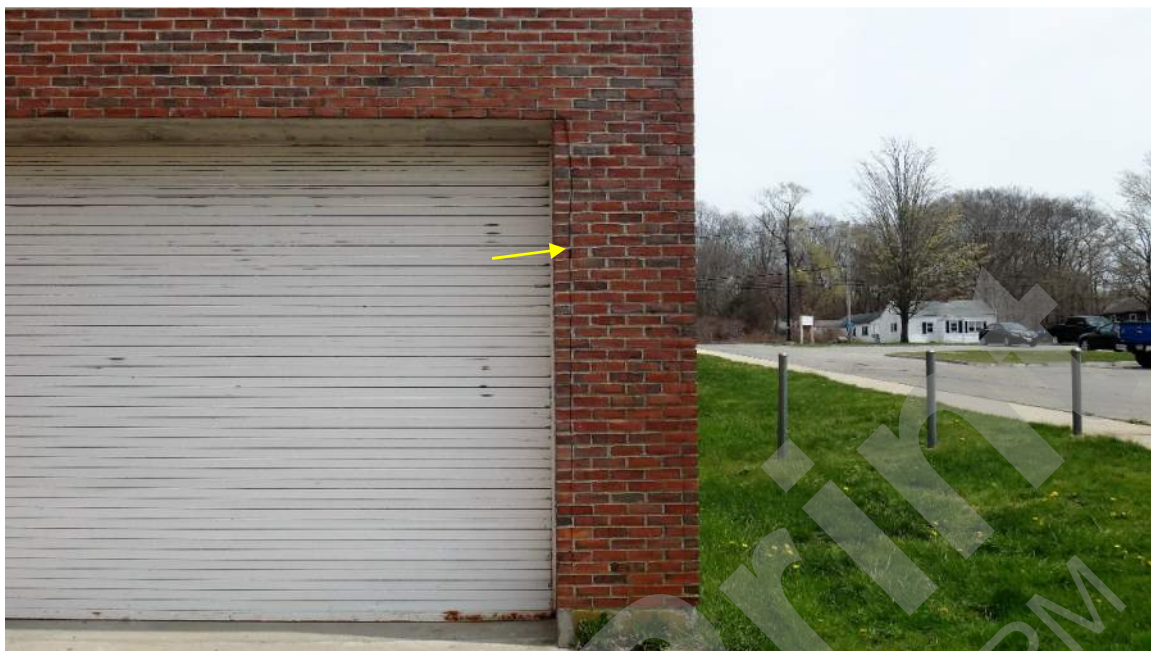
PHOTO #20

This photo shows an example of a crack in the exterior brick veneer. Note the displaced brick in the center of the image.

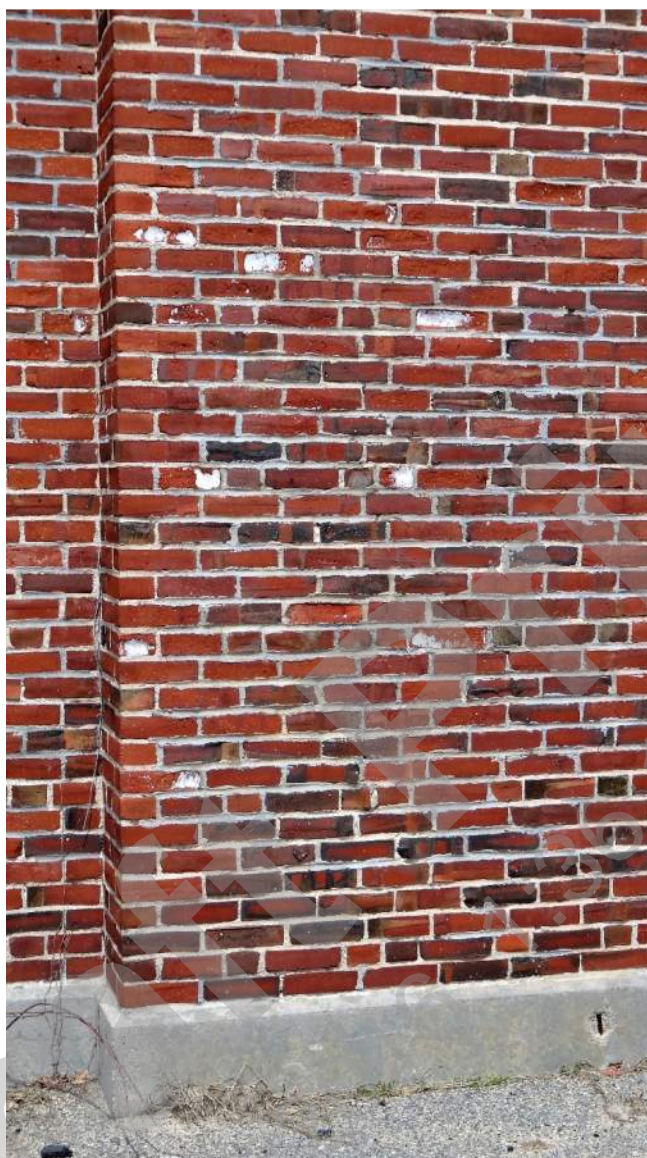
PHOTO #21

locations around the building perimeter and at the chimney (Photos #21 and #22):

- **COMMENT:** Brick deterioration and spalling is typically caused by repeated exposure to freeze-thaw cycles or poor manufacturing of the brick. Deteriorated masonry should be cleaned and repointed, and spalled bricks should be replaced in kind.

This photo shows an example of deteriorated and spalling exterior brick veneer.

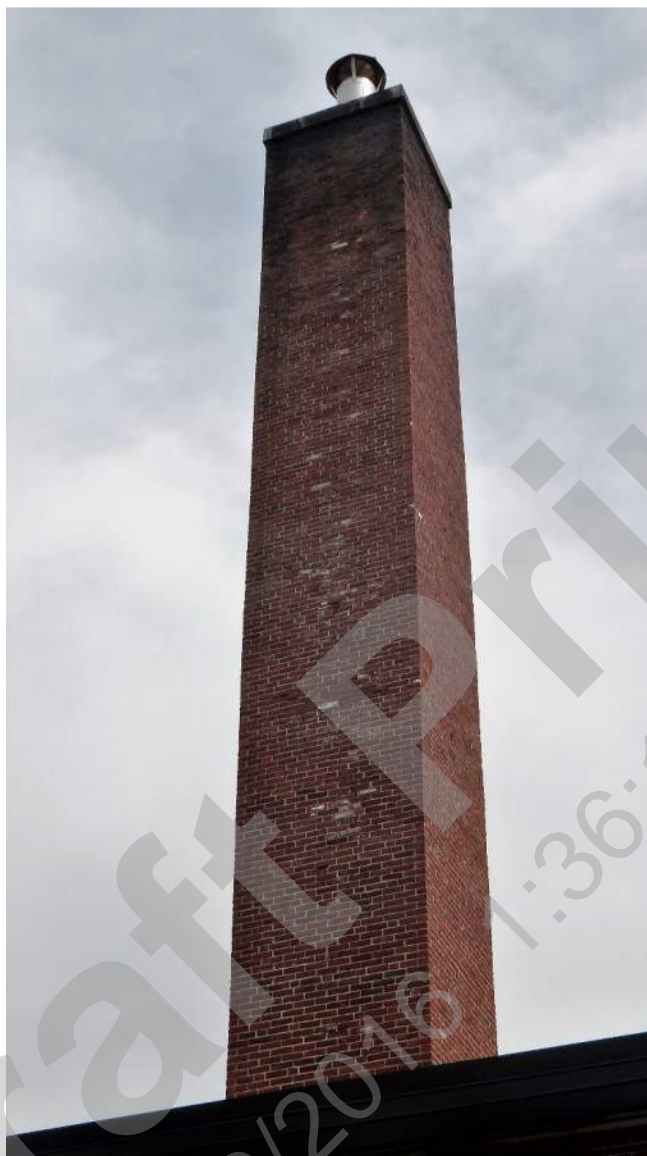
PHOTO #22

This photo shows an example of the deteriorated brick at the existing chimney.

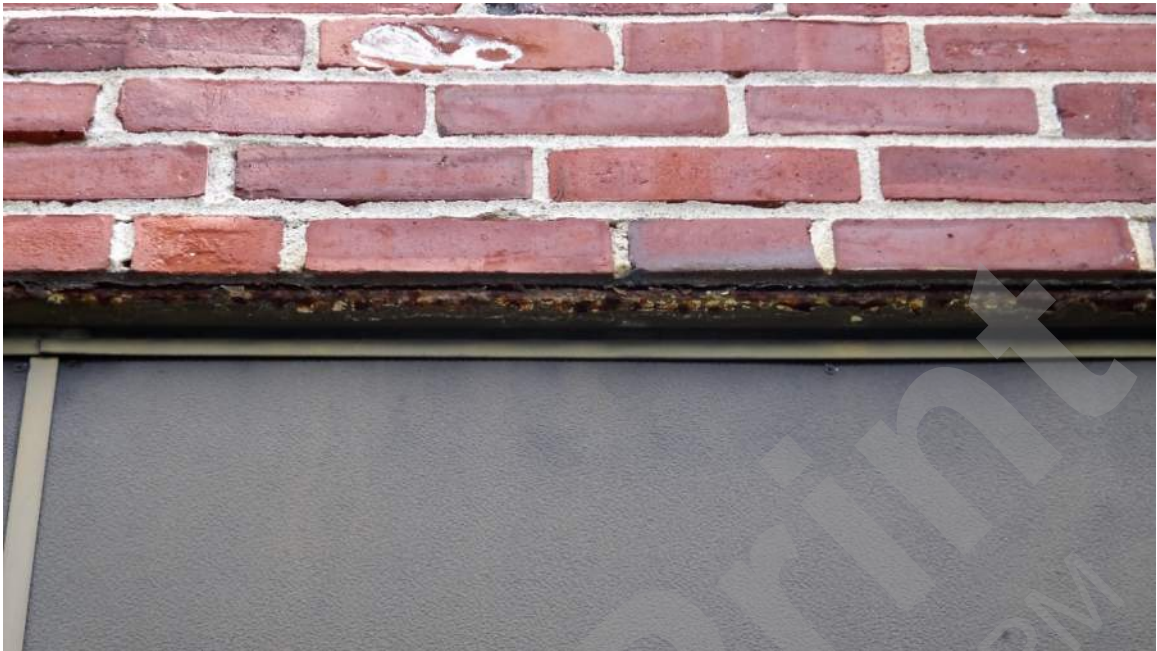
PHOTO #23

- **Minor to moderate rusted steel veneer lintels (Photos #23):**
 - **COMMENT:** Rusted steel veneer lintels is caused by exposure to the elements. Steel veneer lintels that exhibit minor rust can typically be cleaned and painted to increase their longevity. Steel veneer lintels that exhibit moderate to severe rust (i.e. delamination and loss of section) should be replaced with new galvanized lintels.

This photo shows an example of a rusted veneer lintel.

- All deteriorated steel lintels will need to be replaced. The lintels will require temporary shoring of the supported masonry, replacement with new galvanized steel angle members, and installation of new flashing.

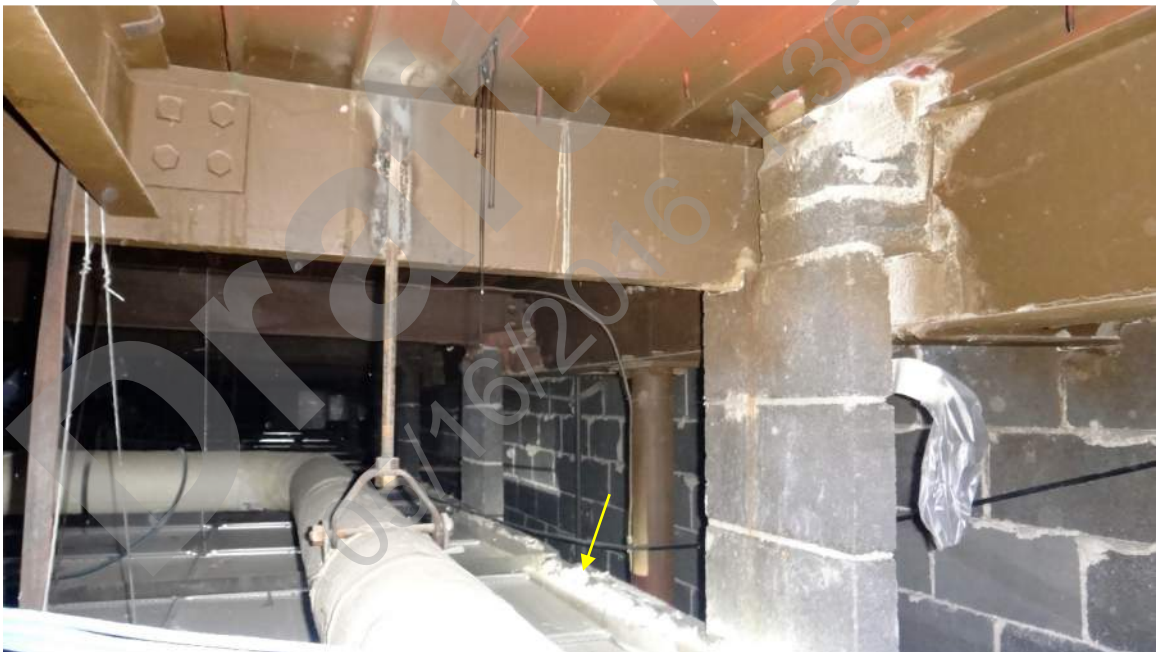
PHOTO #24

- **Interior nonbearing masonry partitions appear to be laterally unbraced at the tops of walls and are likely lacking restraint at the base of wall as well. Additionally, the existing partitions do not meet the minimum height-to-thickness or length-to-thickness ratios for nonbearing masonry walls prescribed by the current Building Code for existing structures (Photos #24 & #25):**

- **COMMENT:** Unbraced or inadequately braced unreinforced reinforced masonry partitions represent a significant seismic hazard due to their inability to resist lateral loads imparted upon them during a seismic event. All nonbearing masonry partitions will require lateral bracing at the top and bottom of the walls and additional wall bracing will be required at approximately 4'-6" on center vertically and horizontally to conform to the Code requirements for height- and length-to-thickness ratios. Alternatively, nonbearing masonry partitions could be removed and replaced with code-compliant nonbearing partition assemblies.

This photo shows an example of the inadequately nonbearing masonry partitions. The piers that extend to the framing above are inadequate to brace the wall during a seismic event.

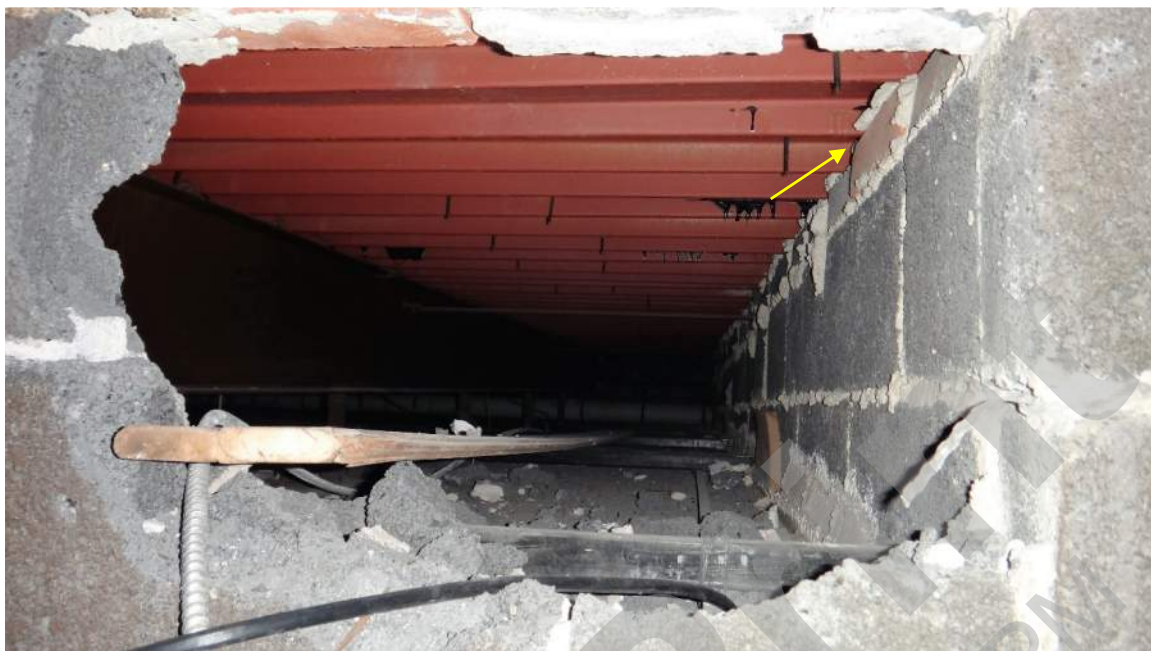
PHOTO #25

This photo shows an example of the unbraced nonbearing masonry partitions. The partitions are built to the underside of the existing structure, but do not appear to have any positive anchorage or attachment at the top of wall.

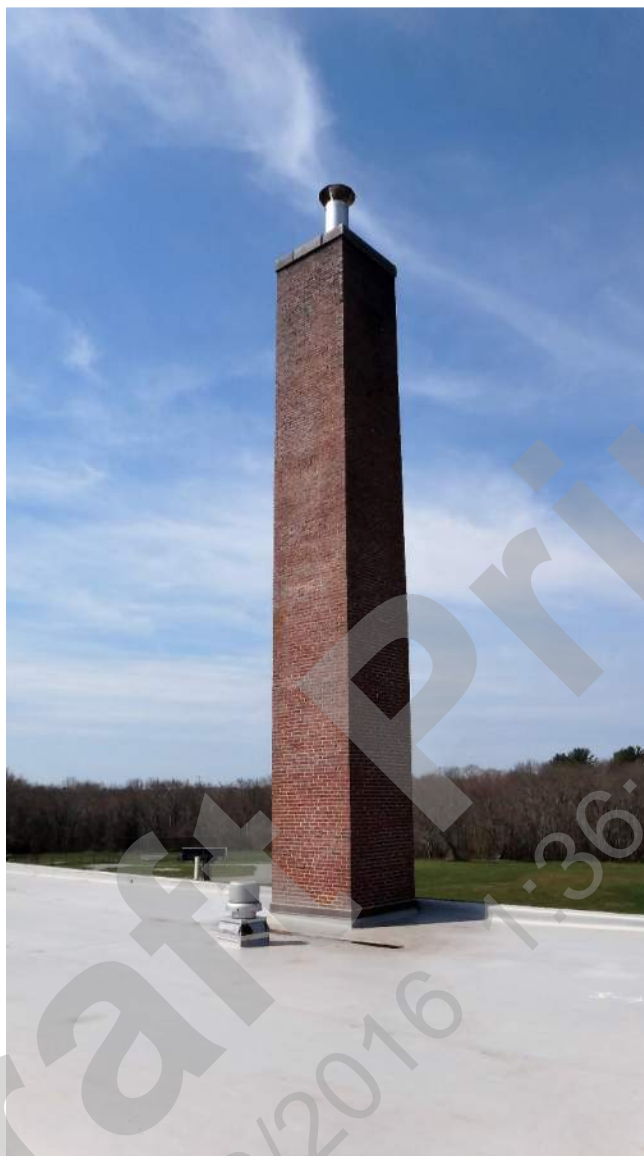
PHOTO #26

- **The existing chimney, which is free-standing for approximately 40 feet above the existing roof, represents a seismic hazard (Photo #26):**
 - **COMMENT:** The existing chimney will require bracing to resist the code-prescribed seismic loads. As an alternative to bracing, the chimney may be substantially reduced in height such that its height-to-thickness ratio does not exceed the code-prescribed maximum of 2.5. The chimney may also be taken down in its entirety.

This photo shows the existing chimney, which extends approximately 40 feet above the existing roof.
