STRUCTURAL EXISTING CONDITIONS REPORT

WESTPORT HIGH SCHOOL
WESTPORT, MASSACHUSETTS

May 16, 2016

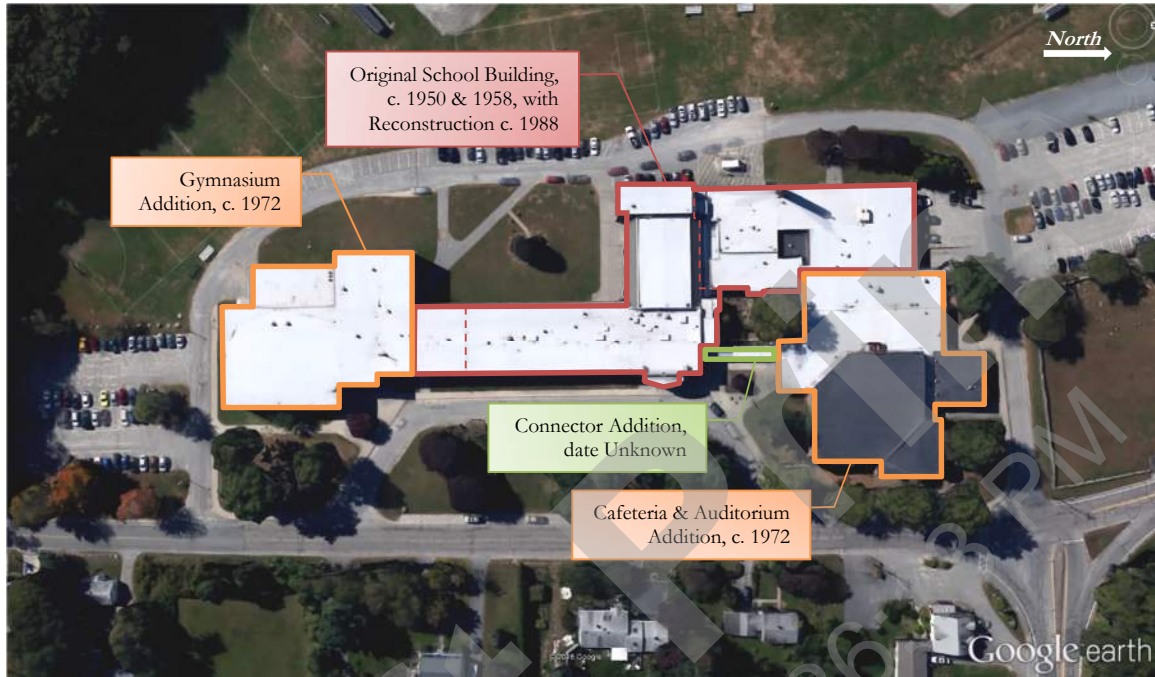
Figure 1 - This is an aerial photo of the existing Westport High School showing the regions of the building referenced in this report.

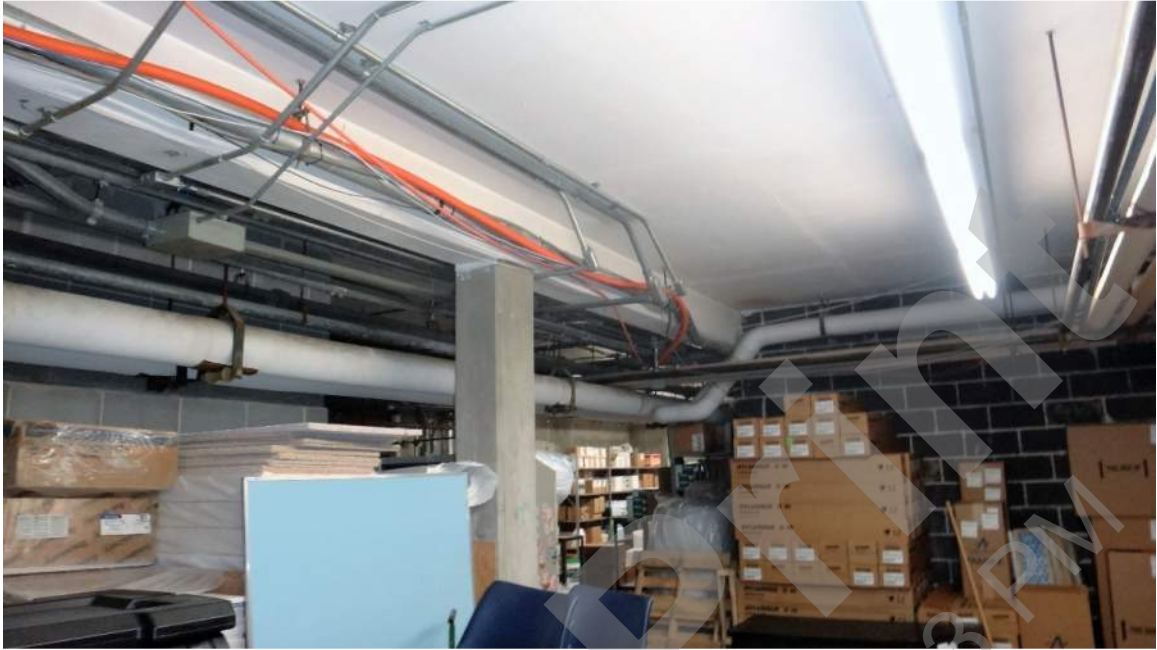
PHOTO #1

The basement and ground floors in all regions appear to be concrete slabs on grade. Foundation and basement walls appear to be cast-in-place concrete. The existing exterior walls appear to be masonry bearing walls comprised of cinder block backup with brick veneer, full-width brick bearing walls, or a combination of the two. Interior corridor walls and demising walls between classrooms appear to be unreinforced cinder block walls in a running bond layout. The ground floor framing above the basement is elevated one-way cast-in-place concrete slab construction, with a 6"± concrete slab spanning between lines of concrete beams and basement walls (span direction varies in different areas above the basement). The beams are supported on cast-in-place concrete columns and the basement walls. Refer to Photographs #1 and #2 for examples of the framing above the basement in this region.

This photo shows the elevated cast-in-place concrete slab construction above the basement in the Original School Building region.

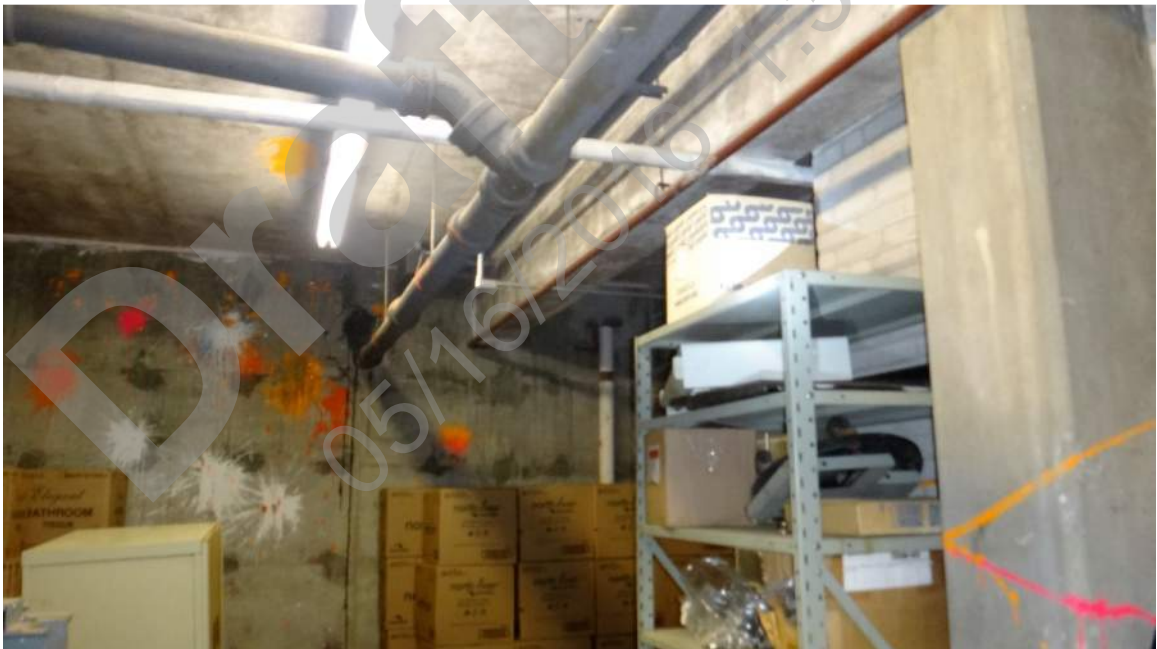
PHOTO #2

This photo shows the elevated cast-in-place concrete slab construction above the basement in the Original School Building region.

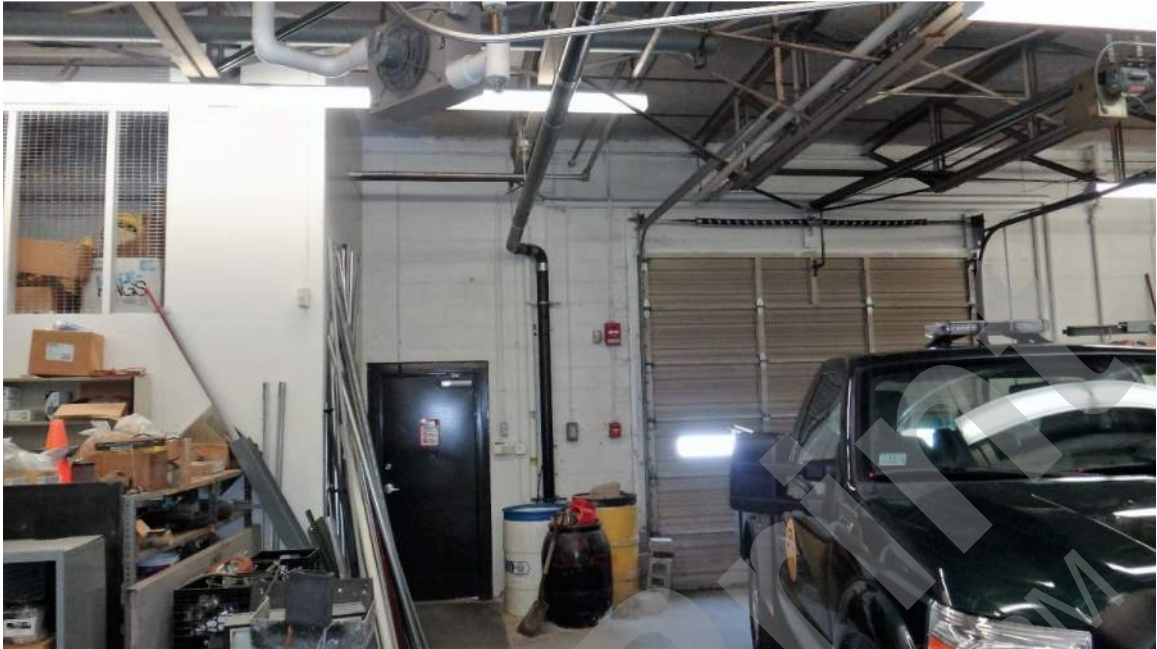
PHOTO #3

The roof framing over the one-story northwestern region of the building is comprised of two different framing systems. Long-span open web steel joists that bear on masonry bearing walls and support a Tectum Tile roof system are present over the Facilities and Maintenance area. The joists and Tectum roof systems are supported on masonry bearing walls. The remainder of the region appears to be steel wide-flange beams and girders that support 1½" narrow-rib metal roof deck. The beams, girders, and roof deck are supported on masonry bearing walls as well as round steel columns. Refer to Photographs #3 through #6 for examples of the roof framing in this region.

This photo shows the existing long-span open-web steel joists and masonry bearing walls that comprise the roof framing in the Facilities and Maintenance area in the Original School Building region.

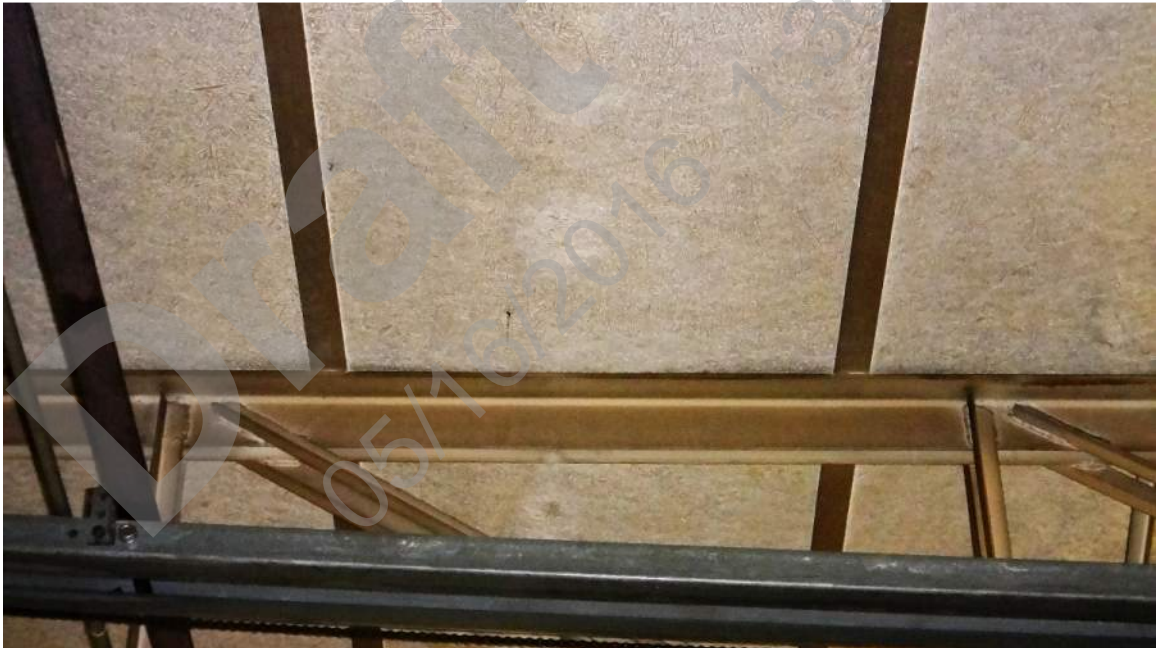
PHOTO #4

This photo shows the Tectum Tile with bulb-tee roof system spanning between open-web steel joists above the Facilities and Maintenance area in the Original School Building region.

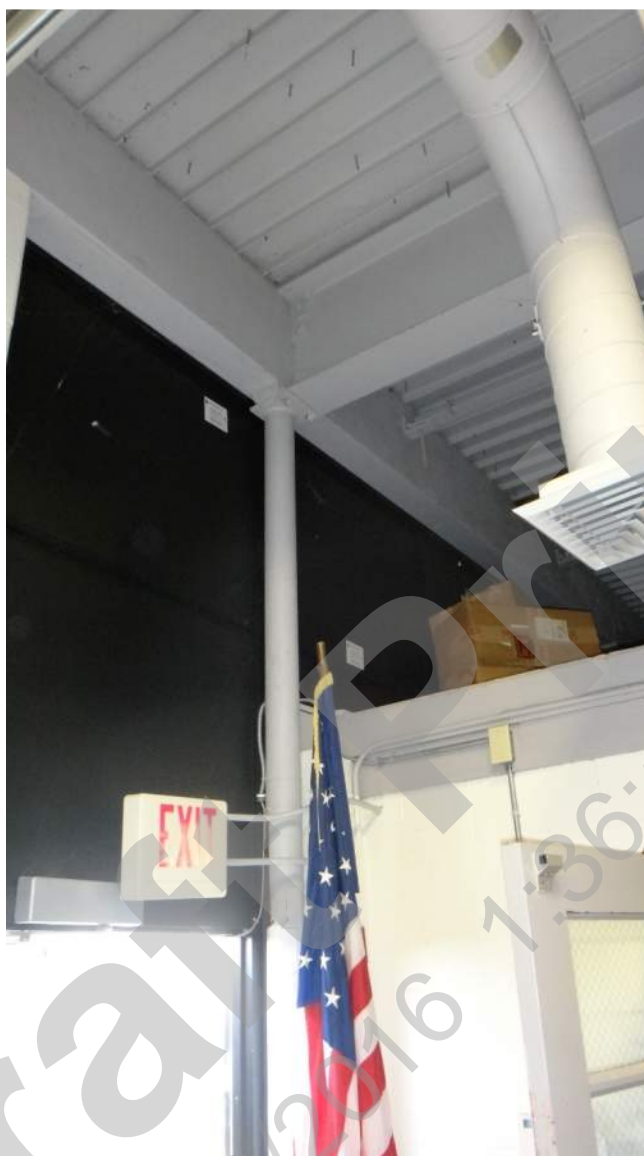
PHOTO #5

This photo shows the existing metal roof deck on steel beams and girders that comprises a portion of the roof framing in the one-story portion of the Original School Building region.

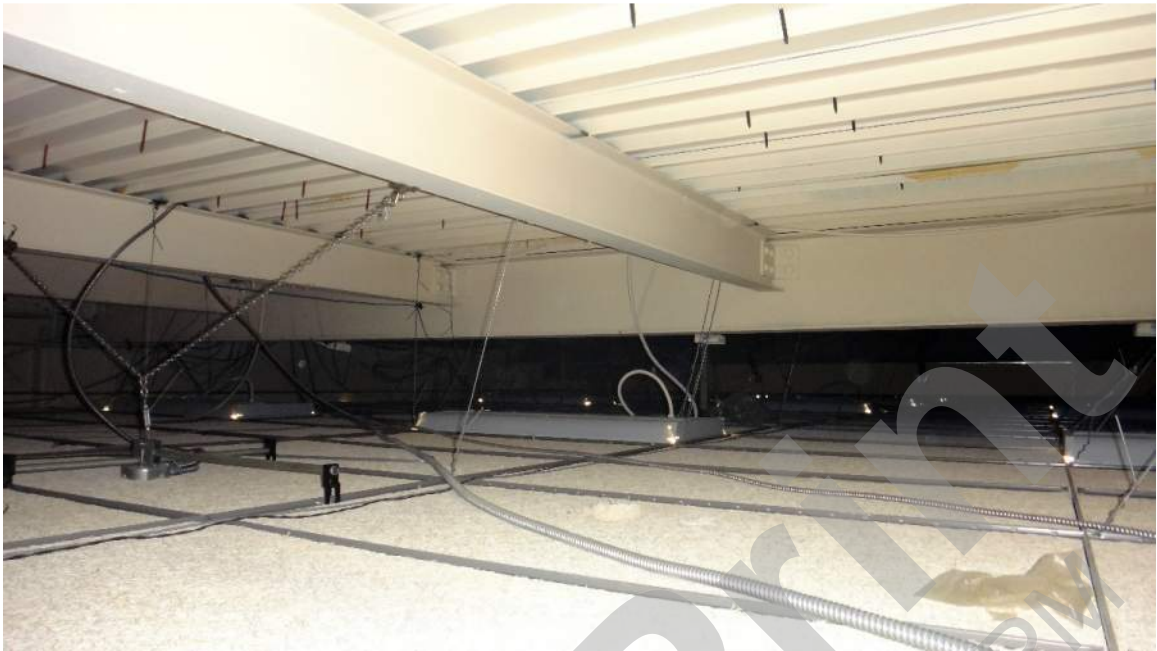
PHOTO #6

This photo shows the existing metal roof deck on steel beams and girders that comprises a portion of the roof framing in the one-story portion of the Original School Building region.

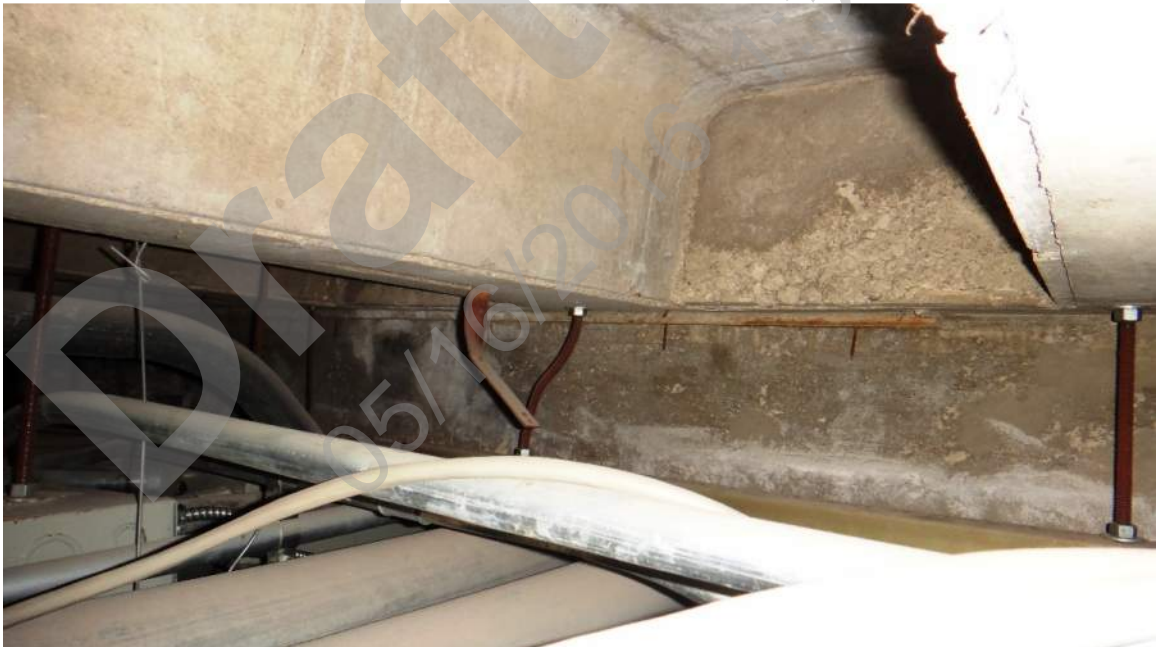
PHOTO #7

The second floor of the two-story southeastern classroom region of the building is comprised of an elevated cast-in-place concrete pan-joint floor slab system spanning east-west between cast-in-place reinforced concrete beams at two interior lines line of support on either side of the main corridor, and cast-in-place concrete encased steel beams at the two exterior walls. The concrete beams span north-south and are supported on cast-in-place rectangular concrete columns at the two interior lines of bearing and on the existing masonry bearing walls and heavy weight Lally columns at the exterior bearing lines. Refer to Photographs #7 and #8 for examples of the floor framing in this region.

This photo shows the existing concrete pan joist floor system with interior cast-in-place beam at the second floor of the two-story portion of the Original School Building region.

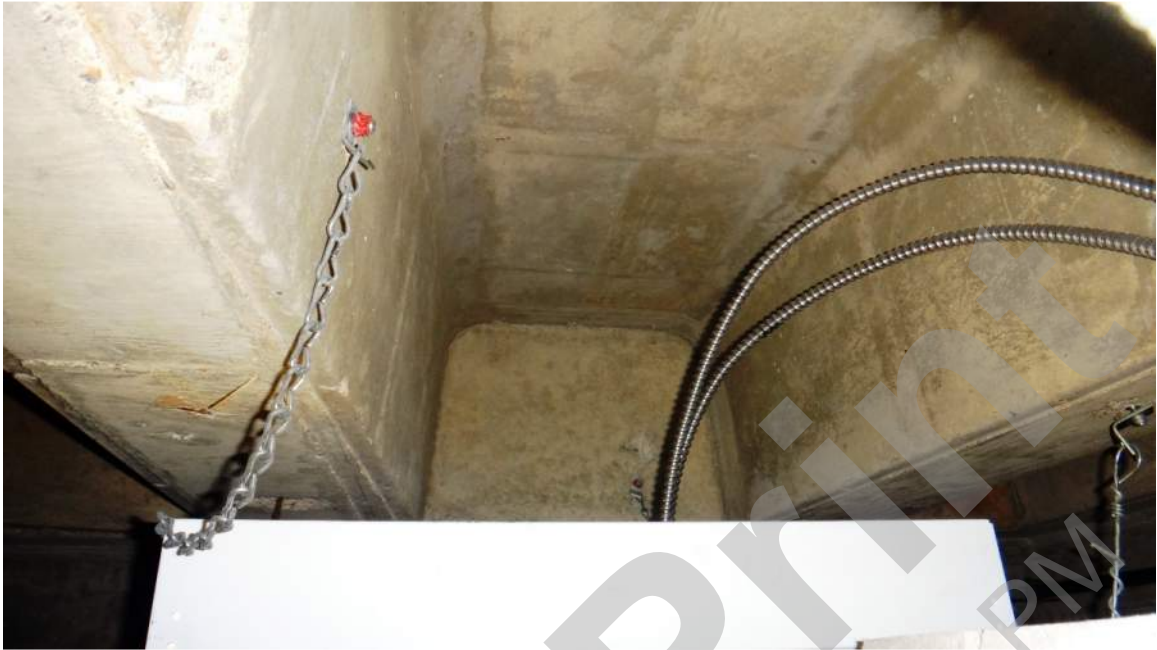
PHOTO #8

This photo shows the existing concrete pan joist floor system with distribution rib at the second floor of the two-story portion of the Original School Building region.

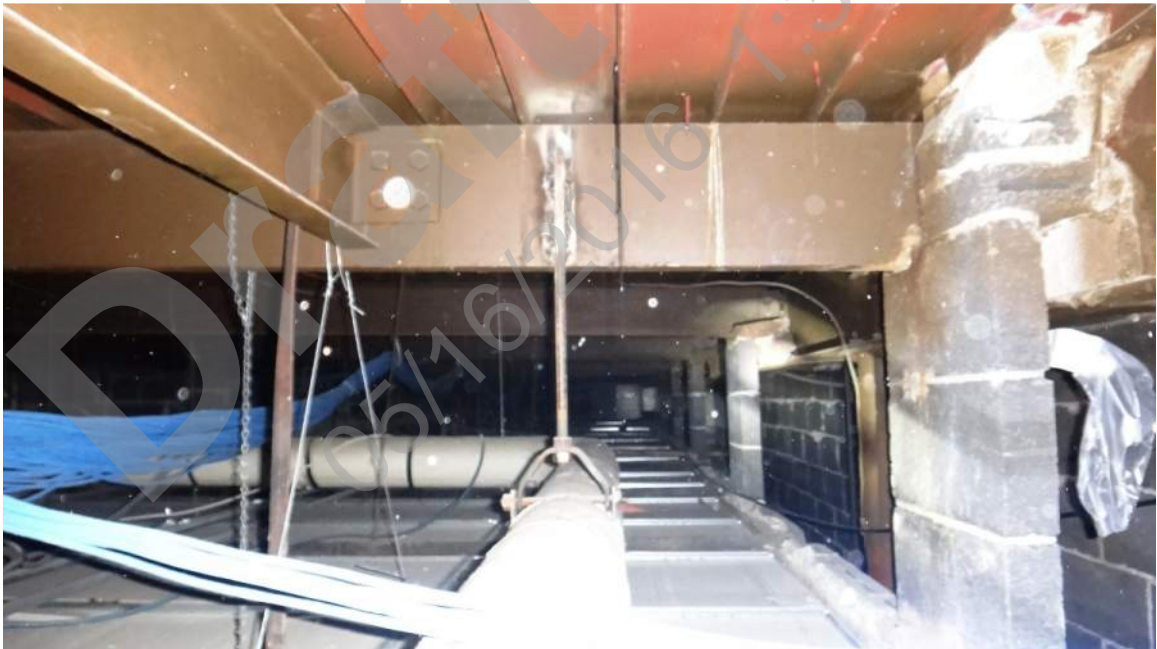
PHOTO #9

This photo shows the existing roof beams and metal deck at the two-story portion of the Original School Building region.

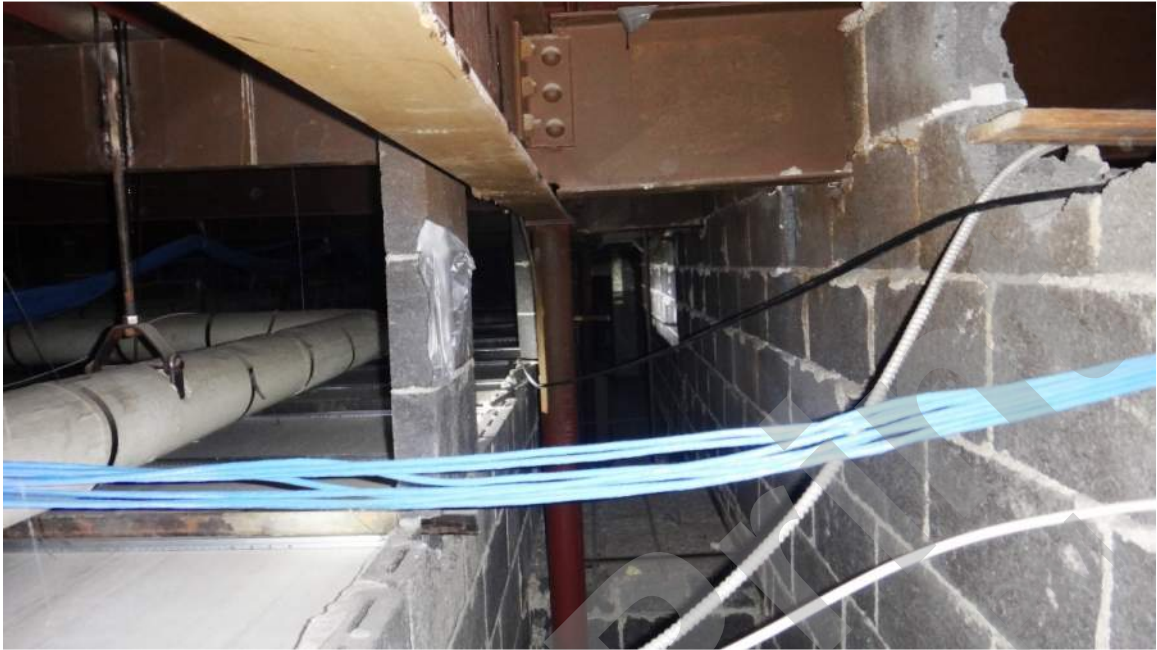
PHOTO #10

This photo shows the existing roof beams and metal deck at the two-story portion of the Original School Building region.

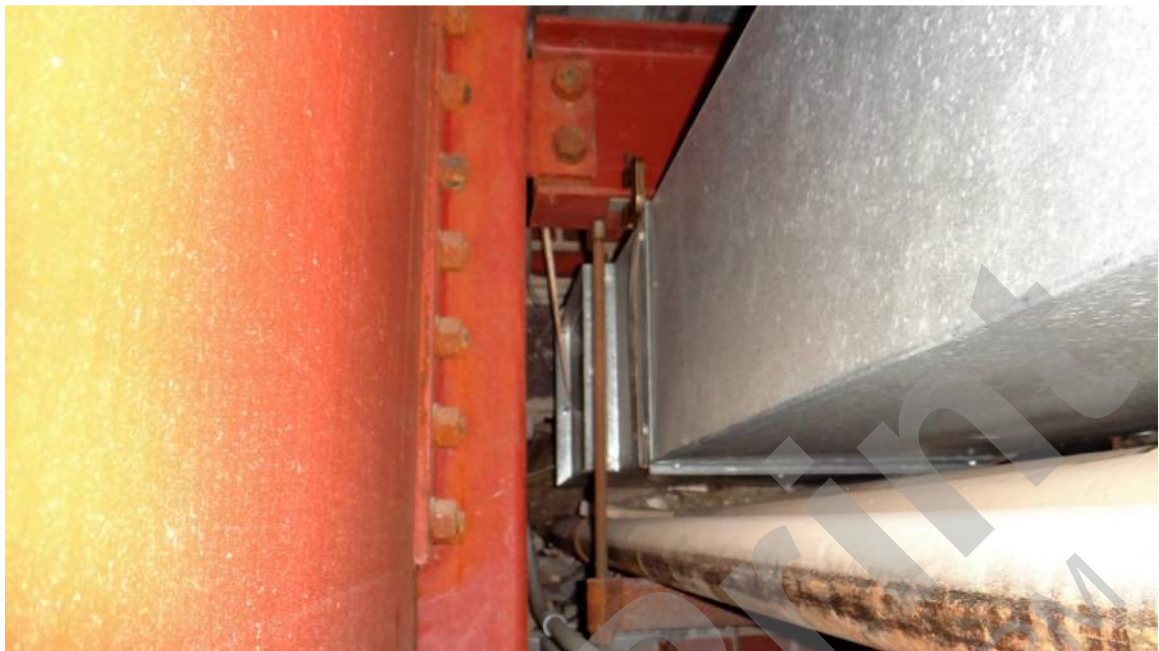
PHOTO #12

The second floor framing appears to be a 4”± thick composite concrete floor slab (2½” topping on 1½” composite metal deck) that spans in the north-south direction between structural steel wide-flange beams. The beams span east-west between structural steel wide-flange girders, which are supported on structural steel columns. Refer to Photograph #12 for an example of the floor framing in this region.

This photo shows the second floor framing in the Gymnasium Addition region.

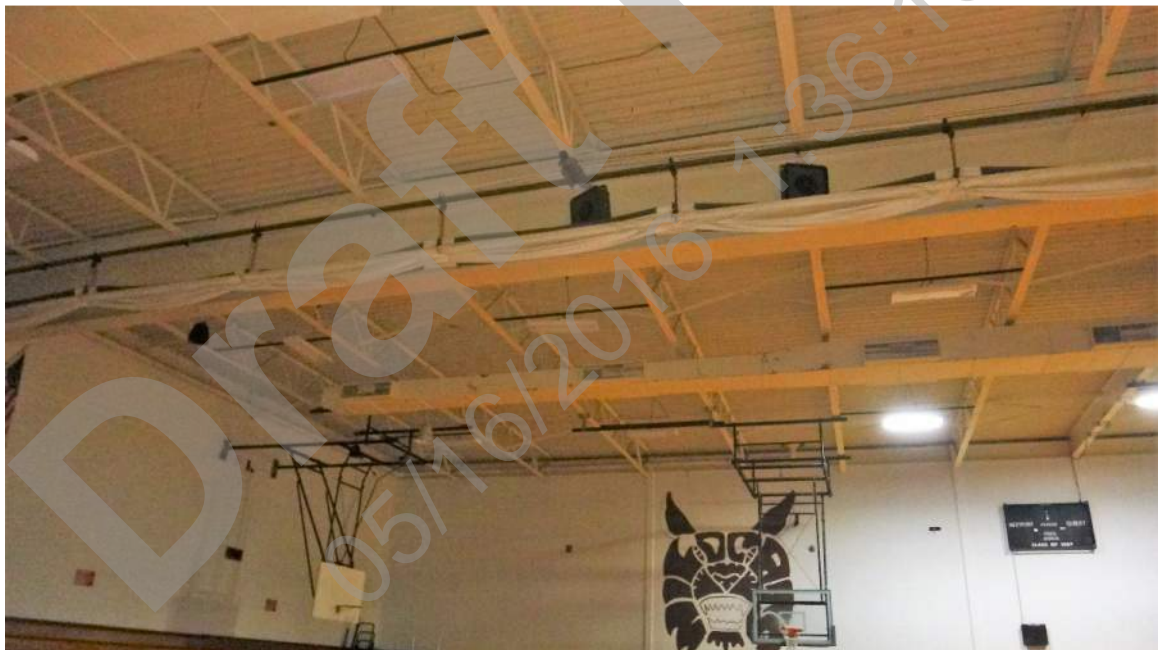
PHOTO #13

The roof framing over the Gymnasium is comprised of 3-inch metal roof deck spanning east-west between steel beams and long-span open-web steel joists. The beams and joists span north-south and are supported on steel wide-flange girders at the north and south bearing lines and a built-up plate girder at the center line of bearing. The girders are supported on structural steel columns. The existing roof framing over the remainder of the Gymnasium Addition is comprised of steel joists spanning east-west between steel wide-flange girders. 1½” metal roof deck spans between the existing joists. Refer to Photographs #13 and #14 examples of the roof framing in this region.

This photo shows the existing roof framing over the Gymnasium.

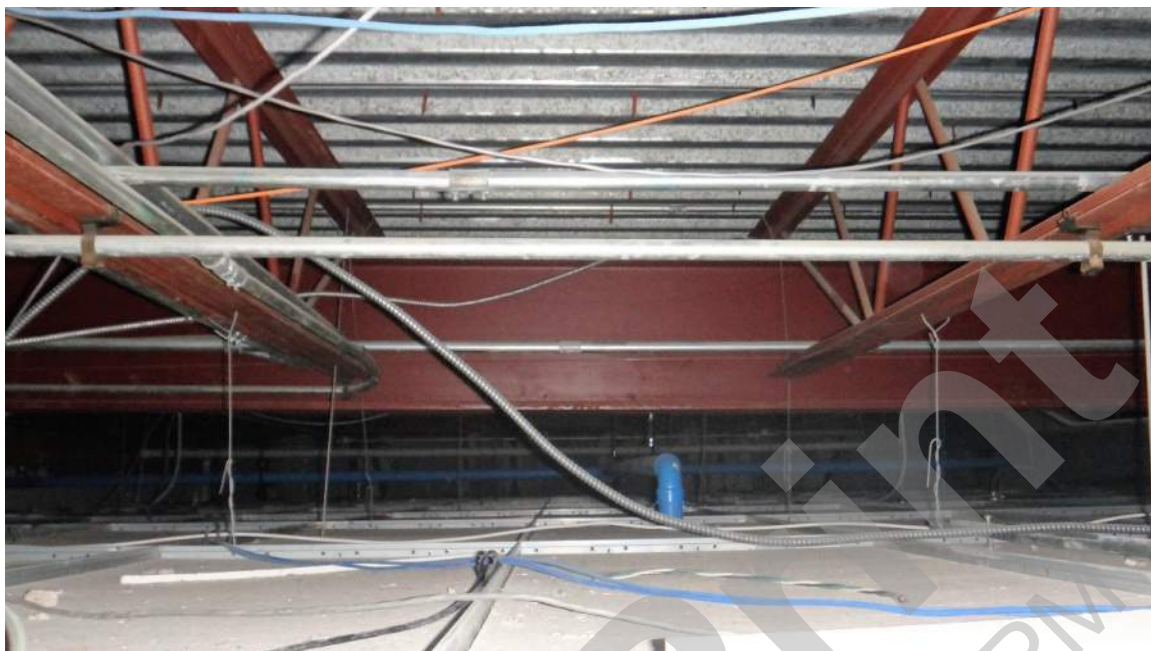
PHOTO #14

This photo shows the typical roof framing in the Gymnasium Addition region.

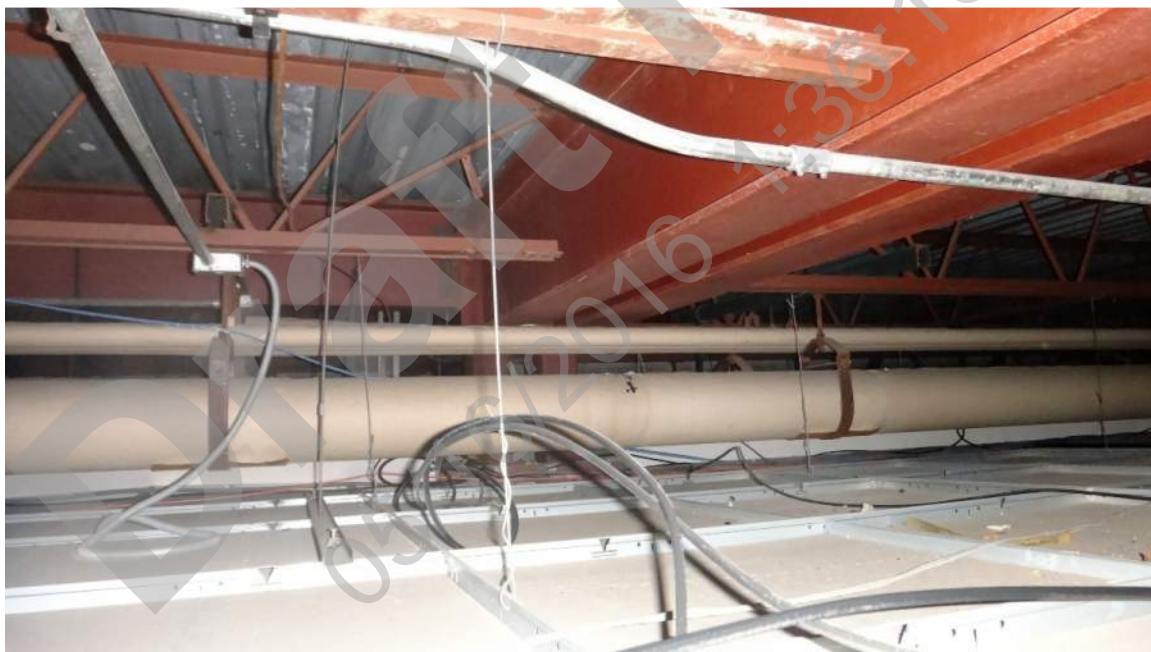
PHOTO #15

The Cafeteria and Auditorium Addition is a one-story addition located to the east side of the one-story portion of the Original School Building. The existing roof framing over the cafeteria portion is comprised of open-web steel joists spanning east-west between steel wide-flange girders, which are supported on structural steel columns. 1½" metal roof deck spans between the existing joists. A 2"± expansion joint runs north-south through the cafeteria portion of the addition. Refer to Photograph #15 for an example s of the roof framing in this region.

This photo shows the existing roof framing over the Cafeteria. Note the double beams on either side of the expansion joint.

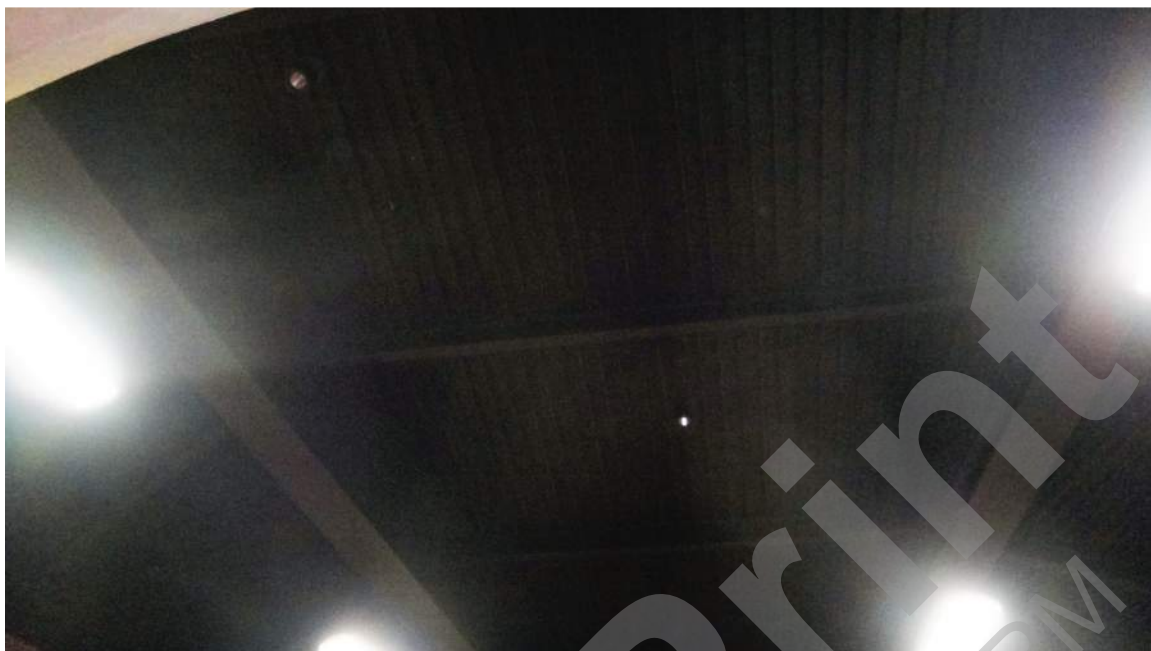
PHOTO #16

The auditorium is a double-height space with a sloped floor for fixed seating. 3"± metal roof deck spans between roof beams the beams, which are supported on three built-up steel plate girders arranged in a radial (fan) pattern centered on the proscenium. The girders are supported on steel columns and a built-up plate girder at the proscenium. A steel-framed mechanical room and catwalk are located at the rear of the auditorium space. Refer to Photographs #16 through #18 for examples of the roof framing in this region.

This photo shows the typical radial roof framing in the Auditorium.

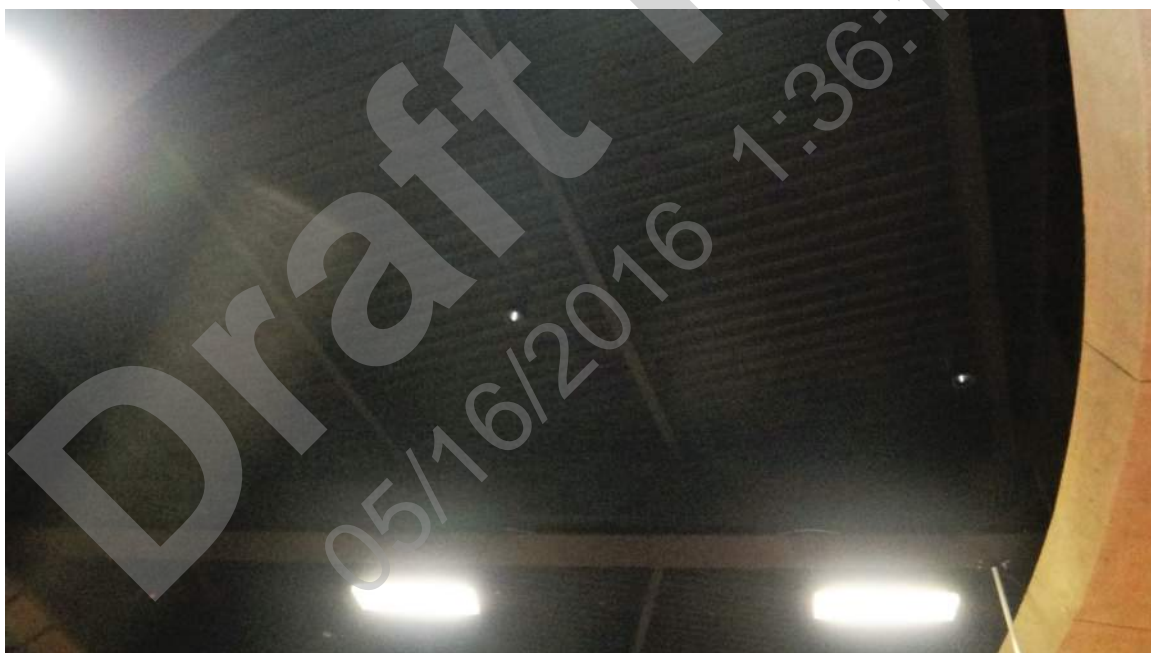
PHOTO #17

This photo shows another example of the typical radial roof framing in the Auditorium.

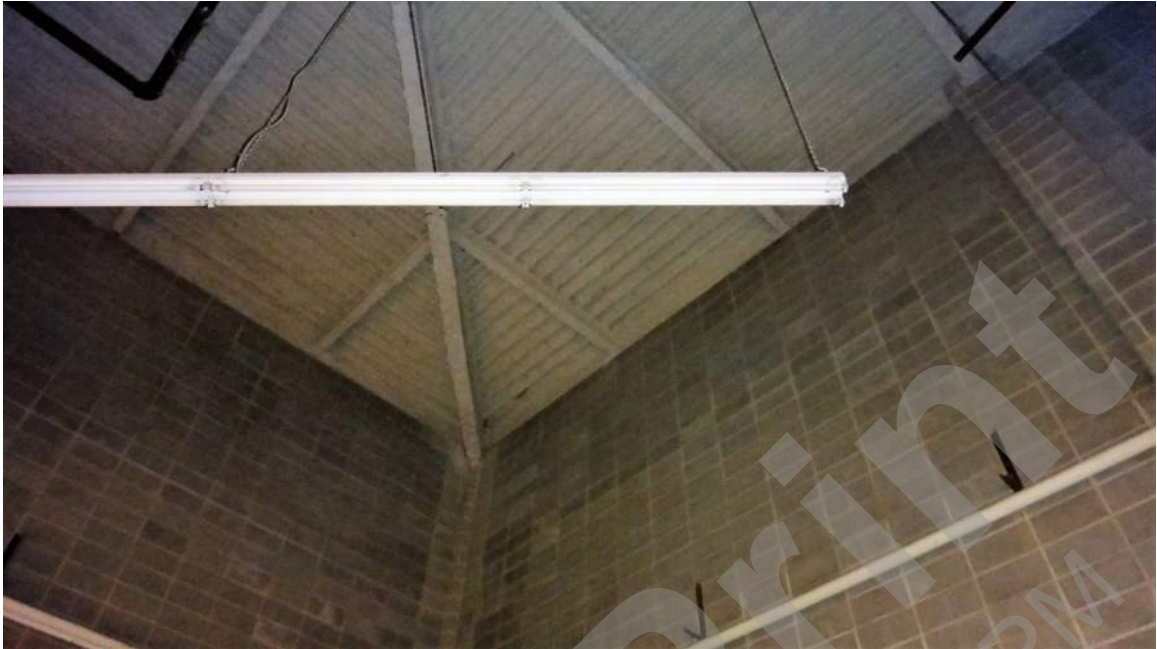
PHOTO #18

This photo shows the typical radial roof framing in the Auditorium above the stage.
